The Cornerstone Inspection Group

# Pre-Drywall Inspection Report

## Sample Inspection Address

Inspection Date:  
00/00/00

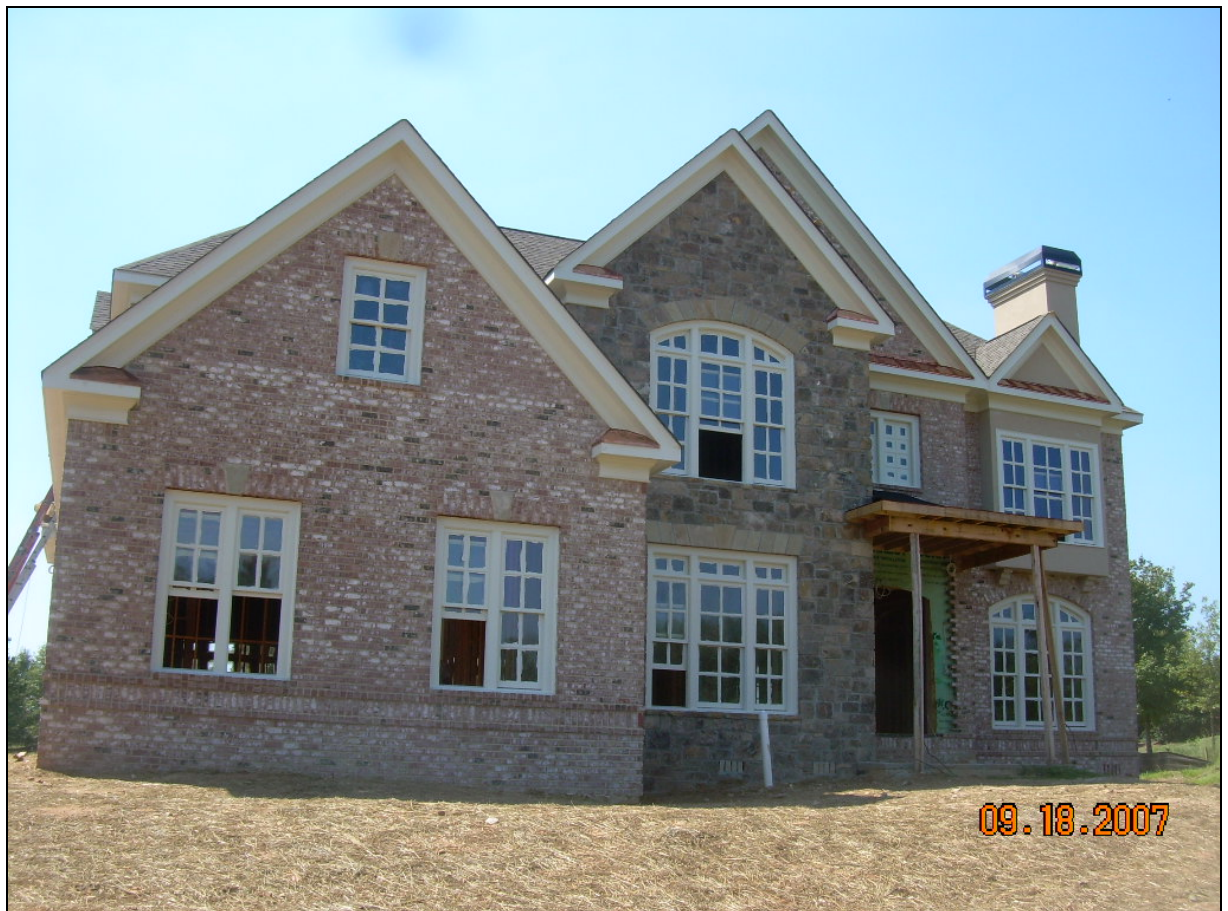
- **Repair, Monitor:** Generally speaking, the house is not ready for drywall installation due to several openings in the exterior veneer and roofing systems, especially as noted at the rear porch (see photo #1) and at the front door (see front cover photo). The house should be totally dried-in as required by code (see R701.2) to prevent moisture intrusion into the wall systems, which can cause mold and mildew to form inside the wall cavities once the house is completed.

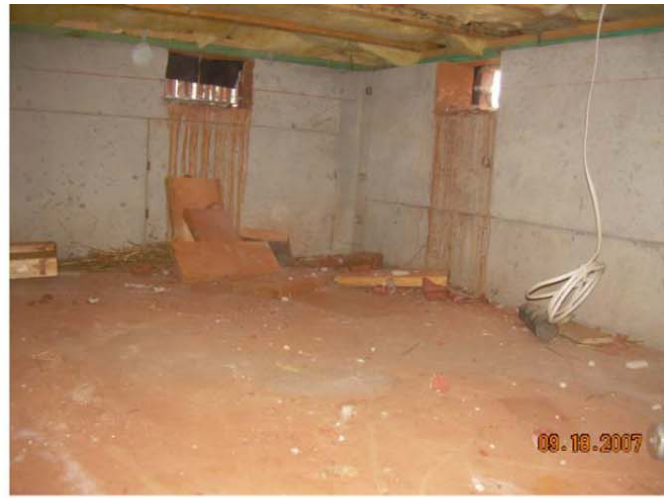
Pre-drywall Sample (2).JPG 2007/09/18 12:44:16

- **Repair, Monitor:** There is evidence of past moisture intrusion in the crawlspace area, especially as noted at the back right corner (see photo #2). Evidence of standing water was noted at the left side of the crawlspace, which could have resulted from a plumbing leak during testing or also from outside moisture intrusion. Wet crawlspaces risk building damage from rot and insects and can cause interior mold or mildew. This condition may vary seasonally and/or with precipitation

intensity. Roof and lot drainage repairs or improvements should be addressed as a first step to controlling moisture intrusion. This condition should then be monitored to determine if additional, potentially costly measures such as an interior french drainage system are necessary to protect the building interior from water and moisture damage. The builder should also be consulted concerning waterproofing and french drainage systems that should be in place to protect the crawlspace from moisture intrusion.

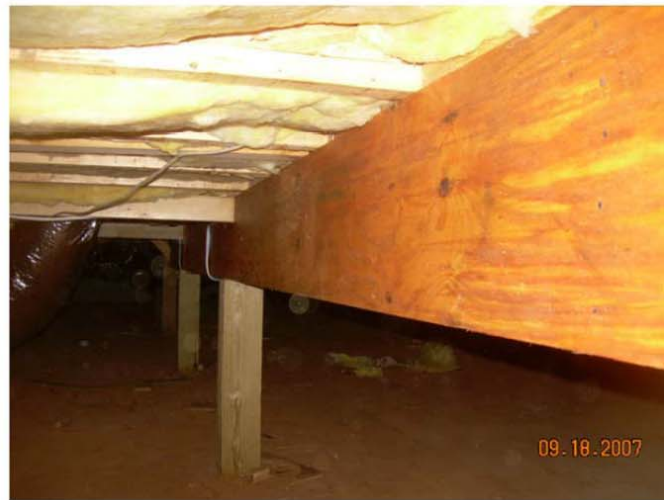
Pre-drywall Sample (4).JPG 2007/09/18 12:46:08

- **Repair:** Additional diagonal bracing tied to the floor joists is needed for the main support girders in the crawlspace to prevent lateral movement (ref R502.9 (recommend at 4' o.c.) - see photo # 4).

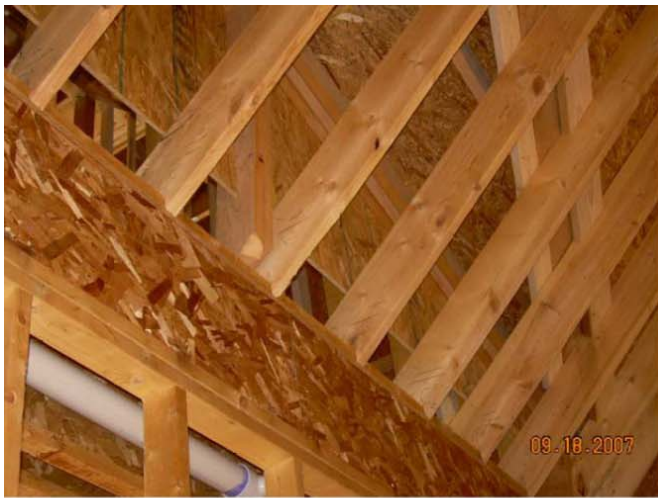
Pre-drywall Sample (5).JPG 2007/09/18 12:08:08

- **Repair:** Rafter ties (straps) are needed at the wall closest to the garage for the vaulted den at the back left corner (see R802.3.1 – photo #5) for proper support.

- **Monitor, Possible Repair:** There does not appear to be adequate wall bracing and sill anchors at the garage door openings as required by most municipalities to protect from wind shear (see Figure R602.10.6.2 – photo #5). Consult with the local building official concerning this requirement and install as necessary.

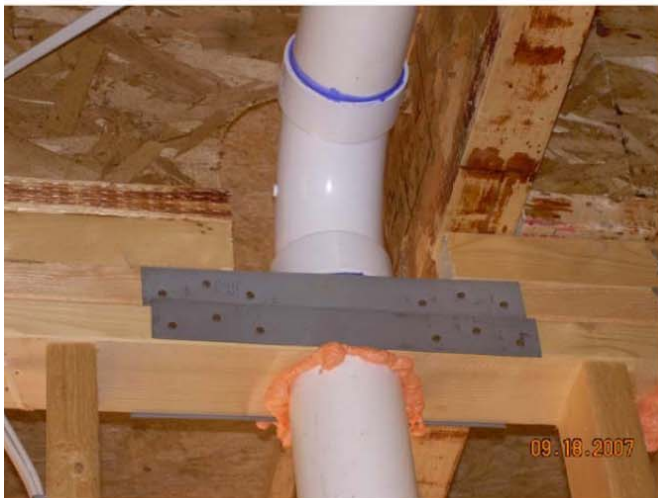
Pre-drywall Sample (7).JPG 2007/09/18 12:17:29

- **Repair:** Missing plate straps as noted at the plumbing sewer line in the wall near the garage should be installed as necessary for proper support and fire blocking (see R602.6.1 – photo #7).

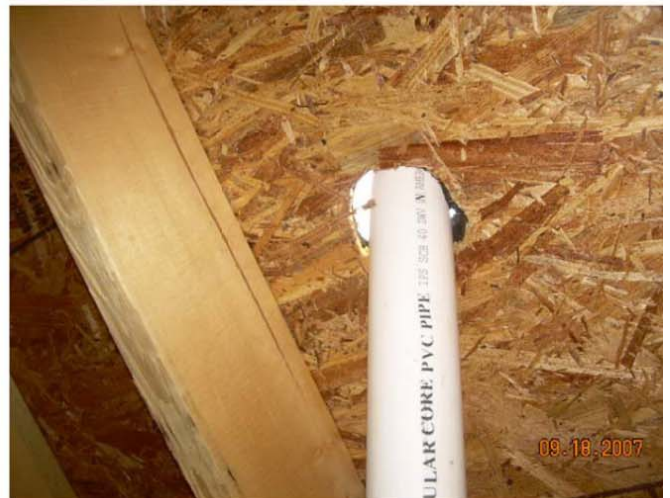
Pre-drywall Sample (8).JPG 2007/09/18 12:37:28

- **Repair:** Daylight was noted at a plumbing vent stack in the attic at the right side (see photo #8). The roofer should replace or install this and all other damaged or missing flashing boots as necessary to insure a watertight roofing system.

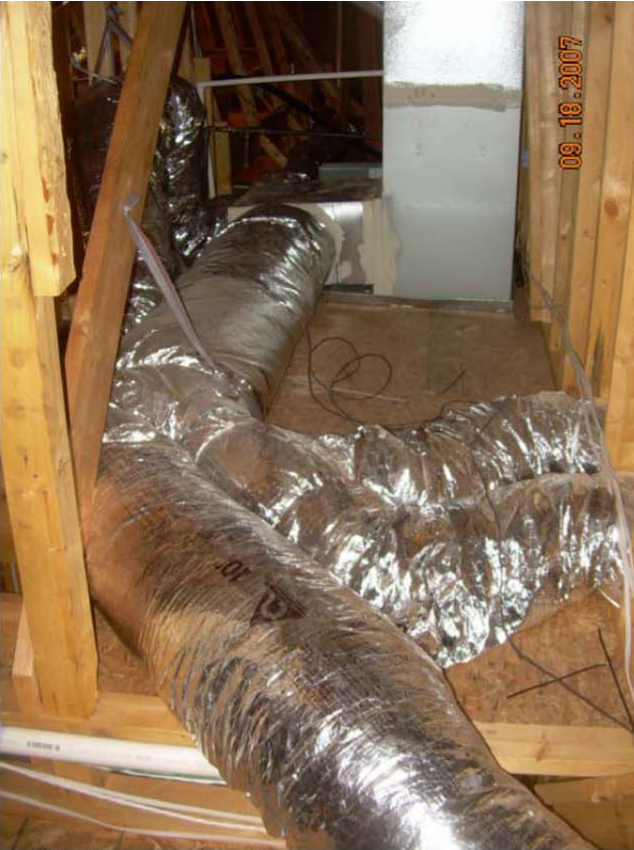
Pre-drywall Sample (9).JPG 2007/09/18 12:35:04

- **Repair:** There is not an adequate walkway to the attic furnace as required to provide a proper access area for the furnace (see M1305.1). Damaged ductwork in the walkway was already noted (see photo #9). Recommend either reconfiguring the furnace and ductwork or install the attic opening on the other side of the furnace.

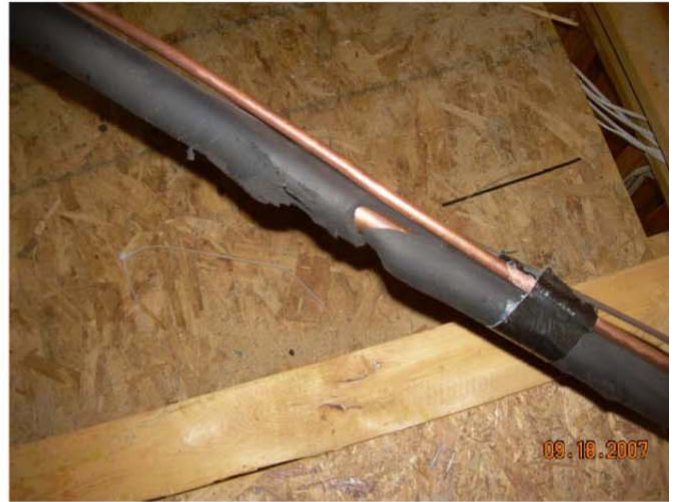
Pre-drywall Sample (10).JPG 2007/09/18 12:36:28

- **Repair:** Damaged and missing insulation on refrigerant lines should be repaired, especially in the attic where condensation can cause damage to interior finishes (see photo #10). All lines should also be insulated near the coils to prevent condensation leaks into the furnace, which can cause rusting and damage to the unit.
