The Cornerstone Inspection Group

# Building Inspection Report

## Middle Aged Home Address; Atlanta, GA

**Inspection Date:**  
July 1, 2009

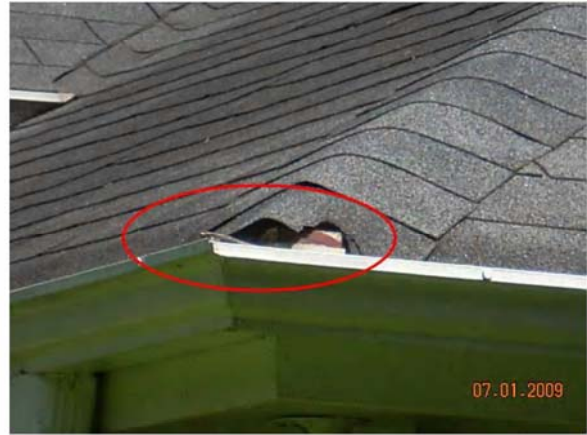
Sample (1)

- **Repair:** *Minor repairs to the roofing are needed, which should be performed by a qualified roofing contractor. Damaged or missing roofing shingles as noted at the front right corner should be replaced (see photo #1). All “eyebrows” (shingles that are lifted up by protruding nail heads) as noted at several locations (see photo #2) should be repaired by lifting the shingles and re-driving the nails in the decking. All holes and exposed nail heads should be caulked and sealed. All roof penetrations should also be examined and sealed as necessary. Signs of previous leaks were noted in the roof decking (e.g. at the front gable (see photo #3), at a rear valley (see photo #4), and at the chimney (see photo #5)), which should be monitored and repaired as necessary. It appears that previous repairs have been made at the chimney flashing (see photo #6).*

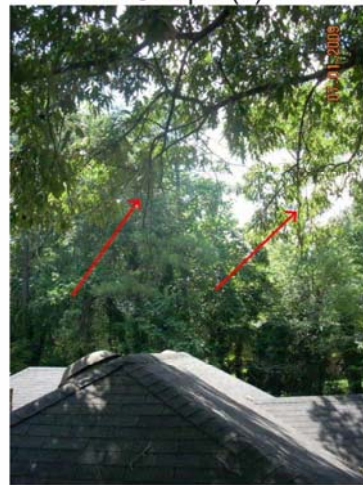
Sample (9)

- **Improve:** *All dead and overhanging limbs as noted at the front should be cut back to prevent further damage to the roofing shingles and gutters (see photo #9).*

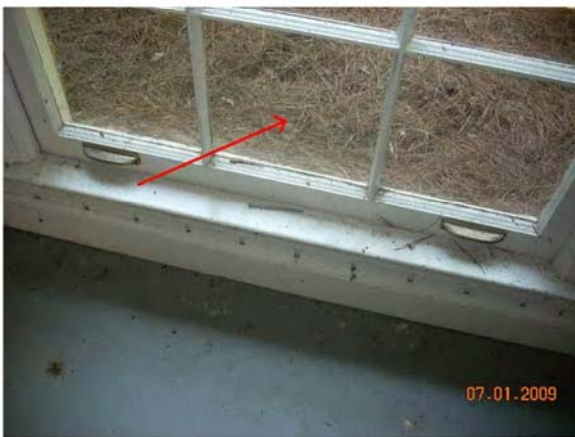
Sample (10)

- **Repair:** The grade appears to be above the sill plate at the front wall of the garage (see photo #10). This condition can lead to termite infestations and moisture damage to the structure. A minimum of 4" (optimum 6") of clearance should be provided between the grade and the top of the slab. The grade in these areas should be lowered to provide such clearance. A drainage structure may be needed to remove water from the area. The ground should slope away from the house at all locations at a rate of one 6" within ten feet of the foundation to prevent moisture intrusion into the basement, especially as noted at the rear next to the sunroom.

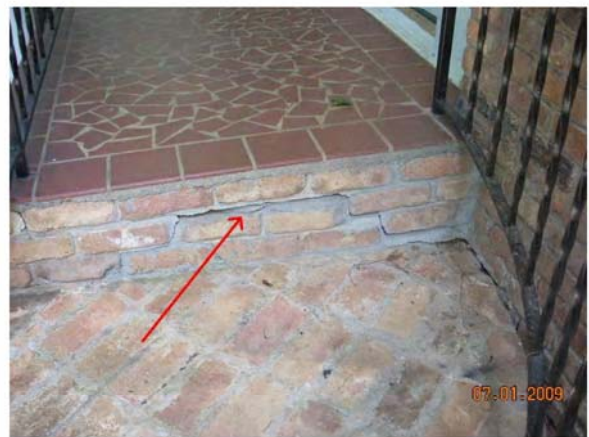
Sample (11)

- **Repair, Monitor:** The front steps and stoop have settled in the past exposing gaps in the brick (see photo #11). These openings should be grouted and sealed to prevent moisture intrusion into the structure and further deterioration of the stoop. These areas should then be monitored for future movement and re-supported if necessary.

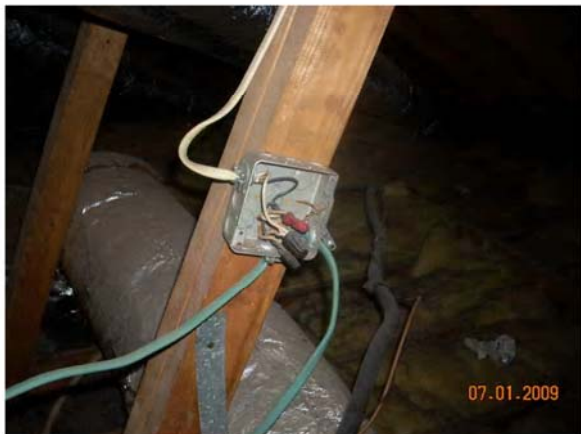
Sample (12)

- *All open junction boxes as noted in the attic should be fitted with cover plates, in order to protect the wiring and to reduce the risks of potential fires that may be caused by poor connections (see photo #12).*

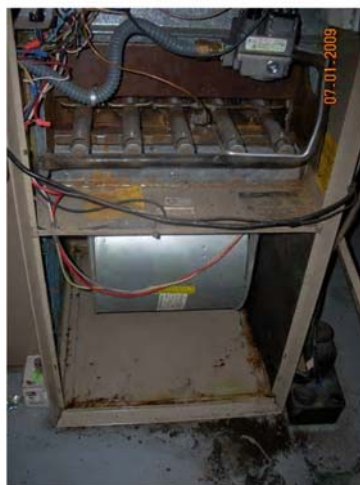
Sample (13)

- **Concern, Safety Issue:** *The heating system requires service and cleaning by a qualified HVAC service company due to rust in the burner chamber area, which can indicate corrosion and damage to the heat exchanger (see photo #13). Soot was noted at several registers, which could also indicate damage to the heat exchanger (see photo #14). Condensate leakage as noted (see “Cooling” Section) may also have caused damage (see photo #15). The heat exchanger should be checked for cracks, which can allow carbon monoxide poisoning to infiltrate the supply air. The air filter should be replaced. This should be a regular maintenance item to assure safe, reliable heat. Given the age of the furnace, it may be near the end of its useful life.*

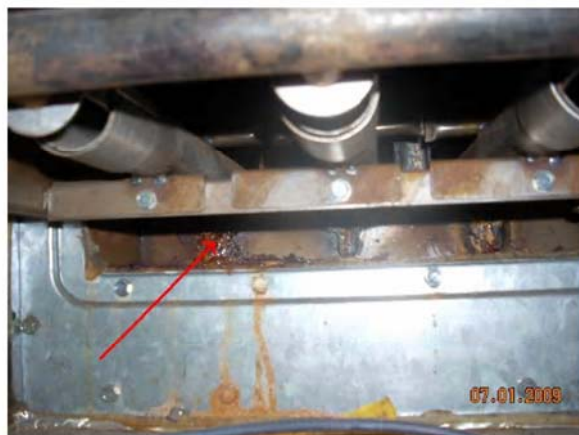
Sample (15)

8. **Concern, Repair:** Evidence of active condensate leakage was observed below the coil of the air conditioning system at the furnace in the basement (see also photo #15). This condition should be investigated and repaired as necessary by the heating and air conditioning service company to prevent further damage to the furnace and other surrounding components. The air conditioning systems should also be serviced and cleaned along with the furnaces. Freon levels should be checked for proper operation and pressure.

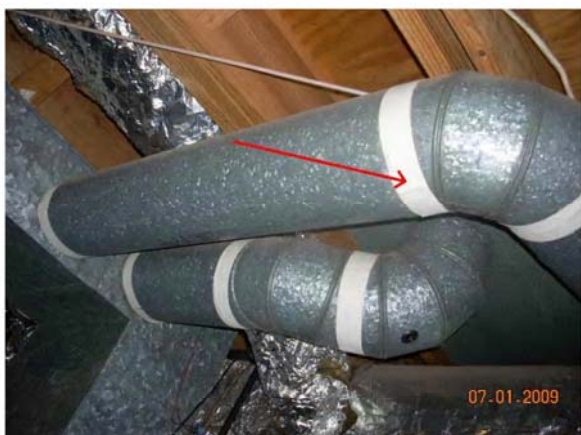
Sample (16)

- **Repair, Safety Issue:** *Asbestos tape as noted on the ductwork in the basement should be encapsulated with mastic for proper protection by a licensed professional (see photo #16). Because of the age of this structure, there may be other material in the home that may contain asbestos not identified by this report. Visit <http://www.epa.gov/asbestos/ashome.html#3> for further information on asbestos in the home.*

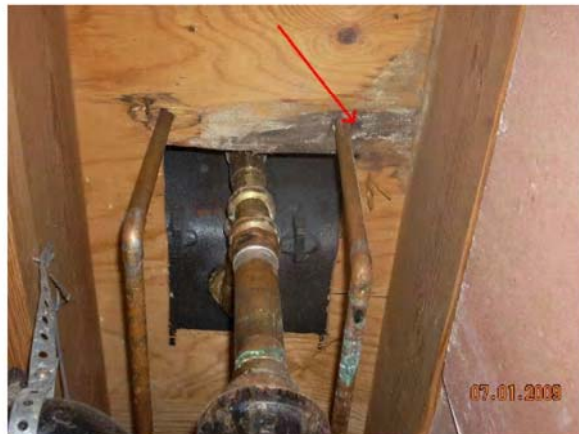
Sample (19)

- a. *The shower in the middle front bathroom experienced major leaks when tested. All piping and fixtures should be inspected and repaired as needed. It may be necessary to replace the tiled shower surround in this bath (see "Interior" Section). Signs of previous leaks were also noted under the middle rear bath, which were dry at the time of the inspection (see photo #19).*

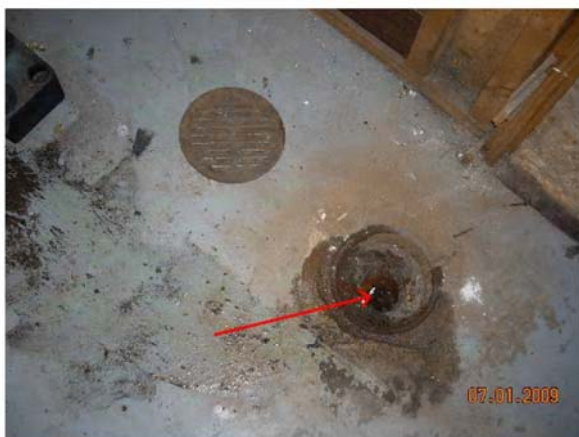
Sample (20)

- d. *The drain in the basement next to the furnace should be checked for proper flow (appears to be clogged or slow draining – see photo # 20)*
14. **Monitor, Possible Repair:** *Due to the excessive water at the furnace in the basement, it could not be determined if leaks were present under the water heaters. These areas should be observed after the water is removed to determine if repairs are needed. Water heaters have a typical life expectancy of 7 to 12 years. The existing unit is in this age range. There was no expansion tank or valve visible above the water heaters. Expansion devices are now required by most municipalities to prevent the back up of hot water into the potable drinking water system and to prevent excessive pressure build-up in the piping systems and will need to be installed when replacing the water heater(s).*

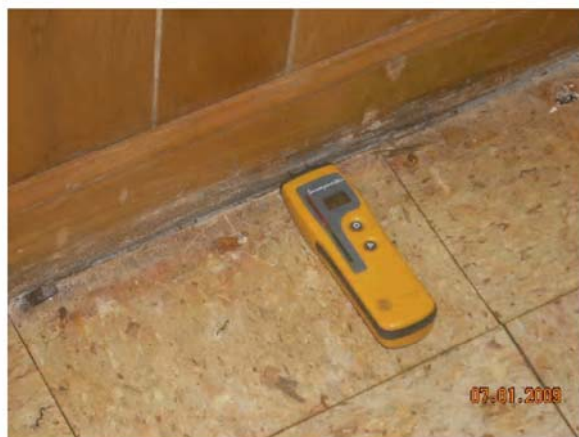
Sample (21)

17. **Concern, Repair:** *The basement shows evidence of active moisture penetration, especially at the back wall (see photo #21). While it is impossible to predict the severity or frequency of moisture penetration on a one time visit to a home, the visible evidence suggests that basement leakage will be a chronic occurrence. Further monitoring of the foundations will be required to determine what improvements will be required. The vast majority of basement leakage problems are the result of insufficient control of storm water at the surface. The ground around the house should be sloped to encourage water to flow away from the foundations. Gutters and downspouts should act to collect roof water and drain the water at least ten (10) feet from the foundation, or into a functional storm sewer. Downspouts that are clogged or broken below grade level, or that discharge too close to the foundation, are the most common source of basement leakage. Please refer to the Roofing and Exterior sections of the report for more information. In the event that these improvements do not solve the moisture problems, excavation, damp-proofing and/or the installation of interior drainage systems may be necessary. Your plans for using the basement may also influence the approach taken to curing any leakage that is experienced.*
