Building Inspection Report

New Construction Address

Inspection Date:
July 6, 2009

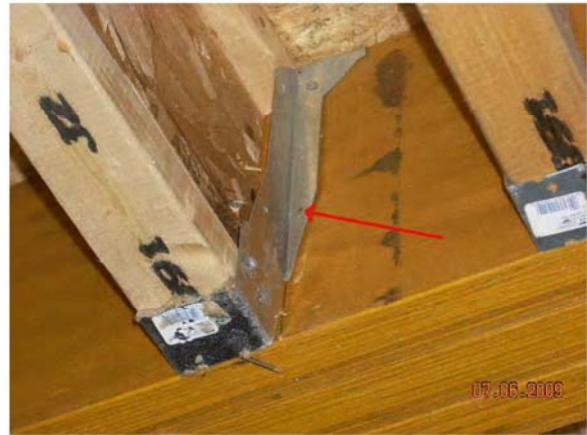
Sample (2)

- All holes in joist hangers should be filled with nails or screws per manufacturer's recommendations. These were missing at the hangers attached to the triple LVL located at the back right area of the basement (see photo #2). Triple LVL's are also typically required to be bolted together instead of nailed (refer to manufacturer's recommendations), which should be performed to properly insure the stability of the beam(s).

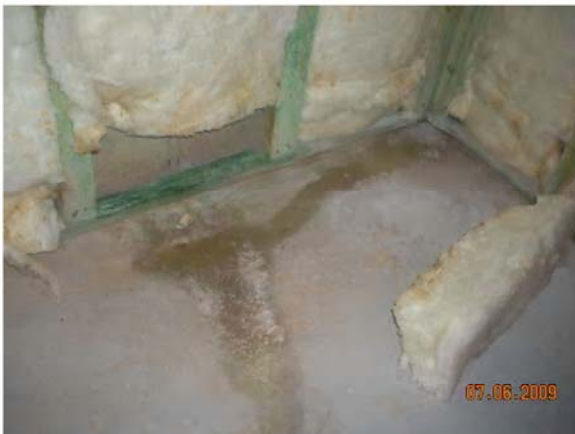
Sample (3)

- **Monitor, Possible Repair:** Signs of possible leaks through the foundation walls were noted at the rear of the basement (see photo #3). This area should be cleaned and then monitored for future activity and repaired by a qualified waterproofing contractor, if necessary. Refer to the "Exterior" and/or "Roofing" Section concerning recommended measures to prevent water accumulation near the foundation, which can cause conditions, which are conducive for moisture infiltration into the basement.

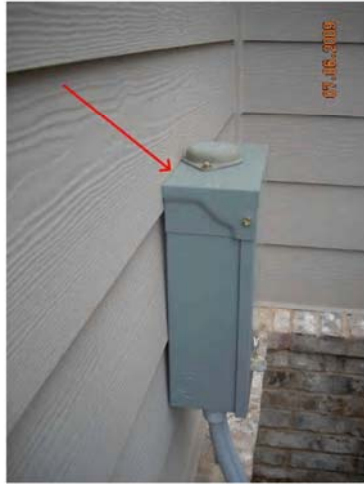
Sample (5)

- **Repair:** All utility penetrations and outlet boxes should be caulked and sealed to prevent moisture intrusion into the structure and to protect the wiring (e.g. as noted at A/C disconnects on right side – see photo # 5). Make sure all other penetrations in the exterior veneer are well caulked and sealed.

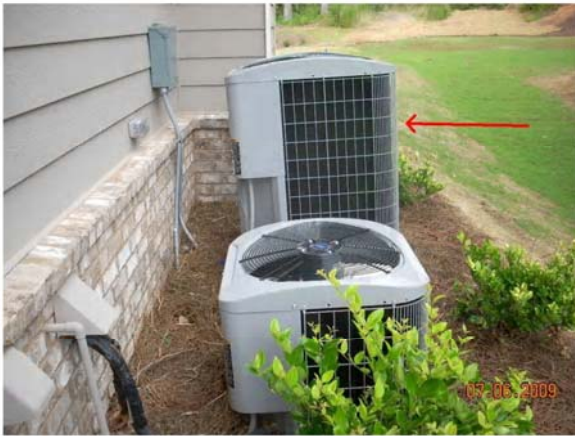
Sample (7)

- **Repair:** *The outdoor unit of the air conditioning system is out of level (larger unit – see photo # 7). This condition should be corrected to allow for proper operation of the fan motor and compressor.*
