Pre-Listing Inspection Report

Sample Address; Atlanta, GA

Inspection Date:
July 9, 2009

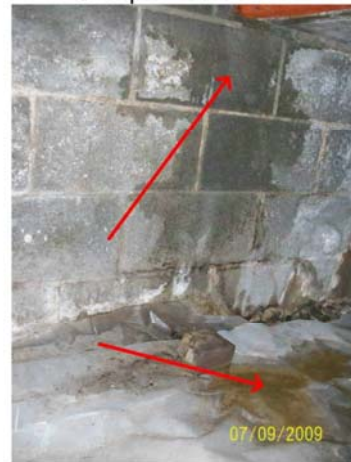
Sample (2)

2. **Repair, Monitor:** *Evidence of active moisture penetration and standing water was observed in the crawlspace as noted at the front wall under the front door (see photo #2). Wet crawlspaces and basements risk building damage from rot and insects and can cause interior mold or mildew (mold air sample tests are not included in this report). Roof and lot drainage repairs or improvements should be addressed as a first step to controlling water in the crawl space (see "Exterior" and "Roofing" Sections – especially concerning the comment about the sprinkler head). After these improvements have been made, this condition should then be monitored to determine if additional measures are necessary to eliminate further moisture intrusion into the crawlspace.*

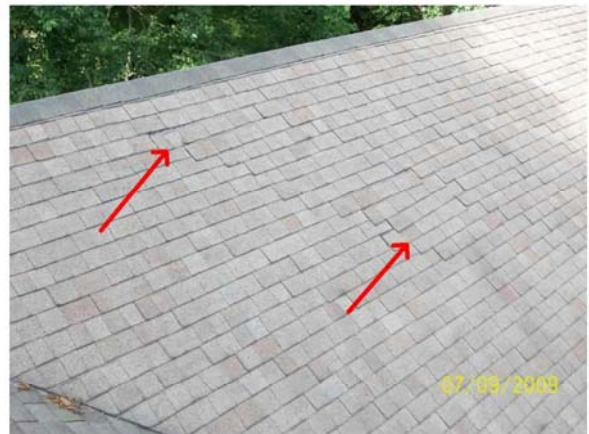
Sample (4)

4. **Repair:** Minor repairs to the roofing are needed, which should be performed by a qualified roofing contractor. Loose shingles as noted at the back left area of the roof should be re-positioned and re-nailed (see photo #4). Damaged or missing roofing shingles as noted at several locations at the ridge caps should be replaced as necessary (see photos #5 and #6). All “eyebrows” (shingles that are lifted up by protruding nail heads) as noted at back right slope over the rear den should be repaired by lifting the shingles and re-driving the nails in the decking (see photo #7). All holes and exposed nail heads should be caulked and sealed (e.g. as noted at the chimney flashing – see photo # 8). All roof penetrations should also be examined and sealed as necessary.

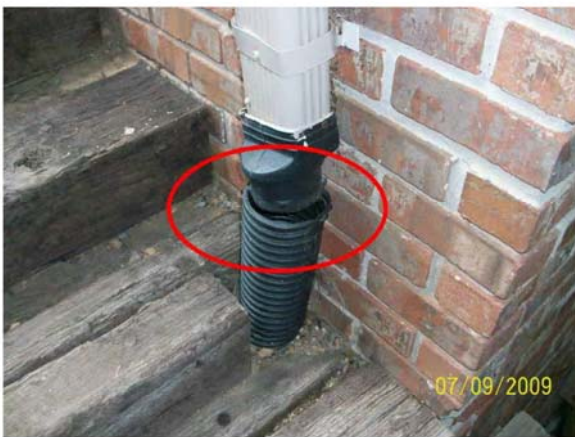
Sample (9)

5. **Improve:** Loose downspout connections to underground piping need to be secured as noted at the rear steps (see photo #9). The piping should be screwed to the downspout and sealed to prevent moisture leakage next to the foundation, a potential source of leaks into the basement and crawlspace. Make sure all piping is clear and free flowing. Ribbed (black corrugated) piping is more prone to become blocked with debris than smooth wall piping.

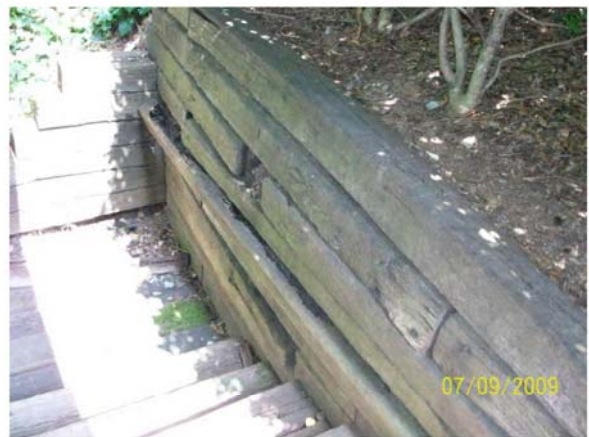
Sample (10)

6. **Monitor, Future Concern:** The wood cross-tie retaining walls as noted at the rear steps show evidence of movement and rot (see photo #10). These walls have a limited life (typically 15-20 years) and should be monitored for repairs and/or replacement that may be needed in the future.

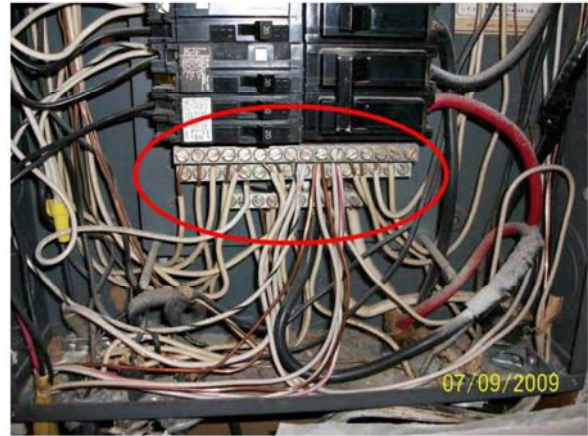
Sample (12)

- b. The neutral wires (white) and ground wires (bare) are tied to the same buss bar in the sub-panel in the main hallway, which would be against current day codes (see photo #12). This should be investigated and repaired as necessary by an electrician.

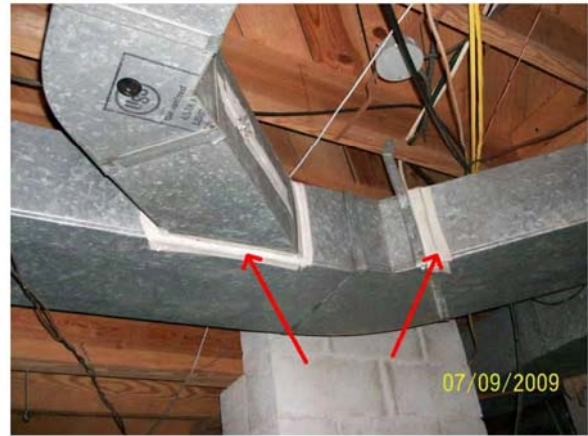
Sample (14)

14. **Repair, Safety Issue:** *Asbestos tape as noted on the ductwork in the crawlspace/basement should be encapsulated with mastic for proper protection by a licensed professional (see photo #14). Because of the age of this structure, there may be other material in the home that may contain asbestos not identified by this report. Visit <http://www.epa.gov/asbestos/ashome.html#3> for further information on asbestos in the home.*

19. **Improve:** *All exposed return air ductwork as noted in the crawlspace/ basement should be properly wrapped with insulation and sealed with tape for proper energy efficiency (see also photo #14).*

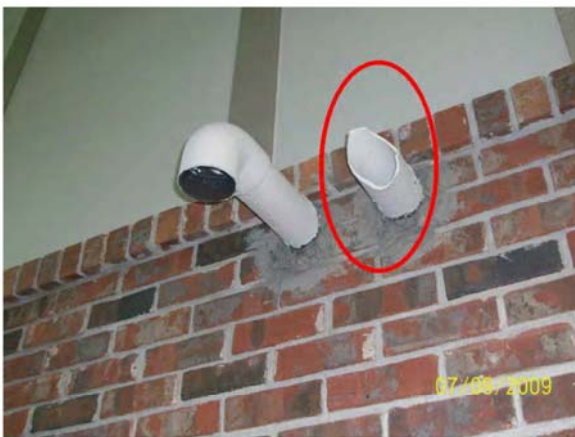
Sample (15)

16. **Repair:** *The damaged furnace exhaust vent as noted at the back left exterior wall should be repaired as necessary for proper venting of the furnace and to prevent moisture and rodent infestations (see photo #15).*

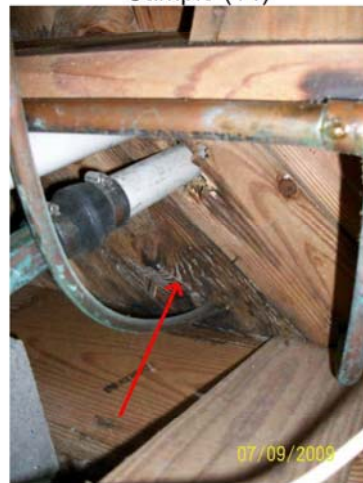
Sample (16)

23. **Monitor, Possible Repair:** *Signs of previous leaks were noted in the flooring system below the kitchen sink, which were dry at the time of the inspection (see photo #16). The piping in this area should be monitored for further leakage and repaired as necessary.*

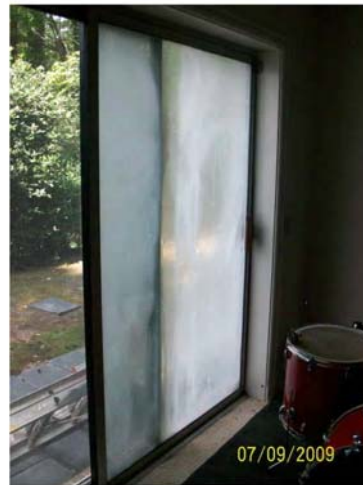
Sample (18)

27. **Repair:** *"Fogged" glass was noted at the basement sliding glass door, which should be replaced as necessary (see photo #18). This condition is typically caused by damaged seals around the perimeter of the insulated glass, which in turn allows condensation to develop between the panes. All damaged glass panels should be replaced for proper visibility through the glass. Other windows may be fogged but cannot be positively determined until the glass is cleaned.*

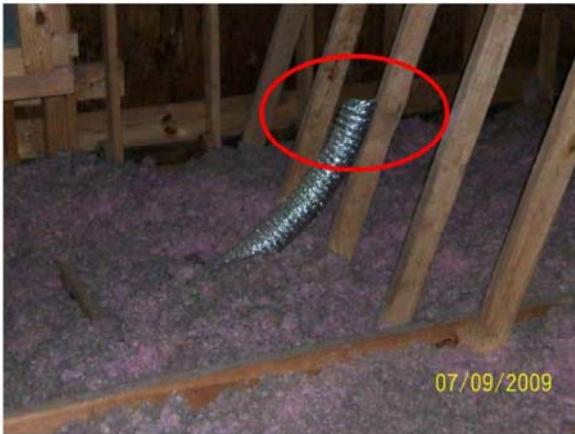
Sample (19)

28. **Improve:** *Bath fans discharging into the attic as noted (see photo #19) should instead be vented to the building exterior to limit humidity build-up in the attic.*

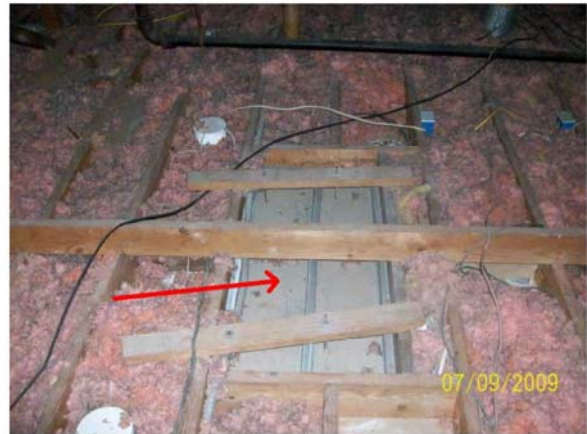
Sample (20)

29. **Improve:** *The attic insulation over the kitchen was missing in several areas and needs installation for proper protection against loss of condition air into the attic (see photo #20). All insulation should be installed for a minimum rating of R30, which is present day code.*
