# Condominium Inspection Report

## Sample Address; Atlanta, GA

June 20, 2009

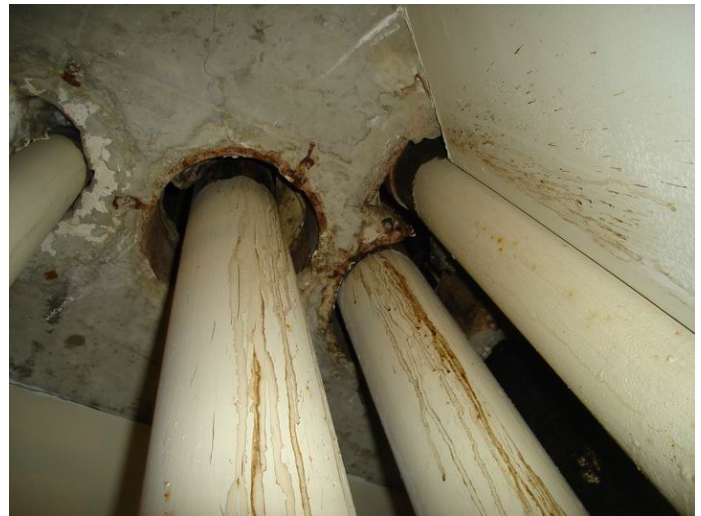
- **Repair, Safety Issue:** Firestops were missing as noted in the furnace closet around the water pipes for prevention of air flow to potential fires above. All openings between floors should be covered (See Photo).

- 5) **Repair, Safety Issue:** Firestops were missing as noted in the furnace closet around the water pipes for prevention of air flow to potential fires above. All openings between floors should be covered (See Photo).
