Pre-Listing Inspection Report

Sample Address; Atlanta, GA

Inspection Date:
July 9, 2009

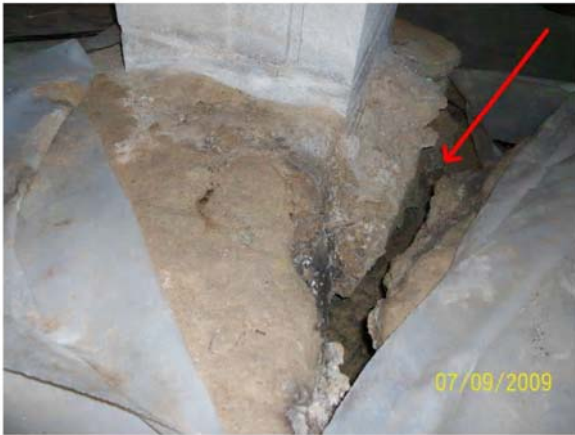
Sample (1)

1. **Monitor, Possible Concern:** *The earthen bank supporting a load bearing pier in the crawlspace noted behind the furnace has eroded over the past and may need to be stabilized by the addition of an interior block retaining wall or pressure grout for proper support of the soil and to prevent movement and settlement of the pier (see photo #1). Recommend having a qualified foundation repair contractor analyze this condition to determine the full extent of the pier support and best method for repair.*

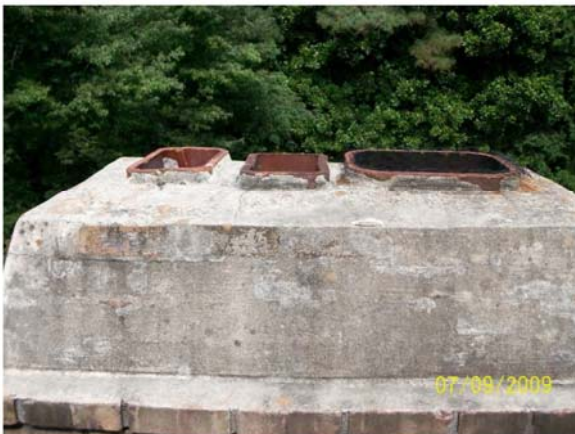
Sample (3)

3. **Repair, Safety Issue:** A rain cap and vermin screen should be installed on the masonry chimney to reduce the risk of damage to the damper and flues and blockages from bird and squirrel nests or other debris, especially since the furnace and water heater vent into one of the flues (see photo #3). The flues should be checked for present damage and/or blockages that may exist.
